Water Quality Management Plan
for the 2008 Water Year

2009 Water Quality Implementation Report

Provo River, Deer Creek Reservoir and Jordanelle Reservoir

Prepared By:
Desert Rose Environmental, LLC

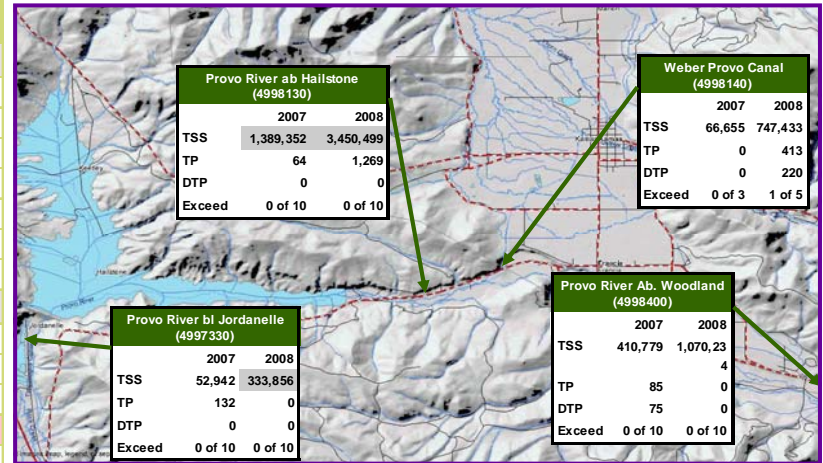
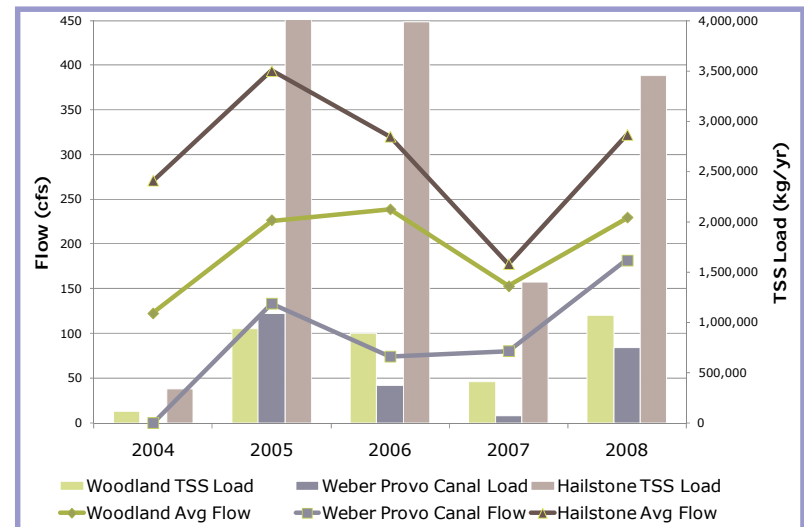
Provo River exhibited greater differences in TSS Load between Woodland and Hailstone in 2004-2008 as compared to previous years. This increase appears to be due to disturbance in the area above Hailstone and not due to water from the Weber Provo Canal.

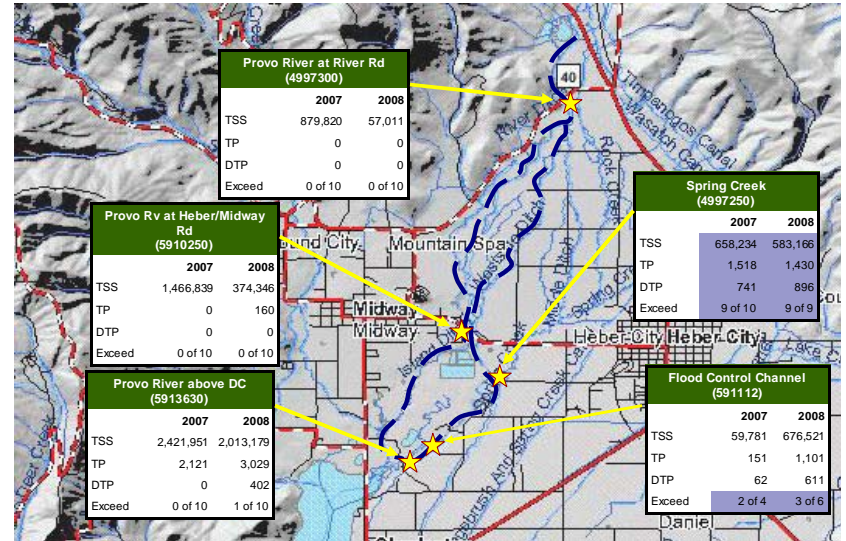
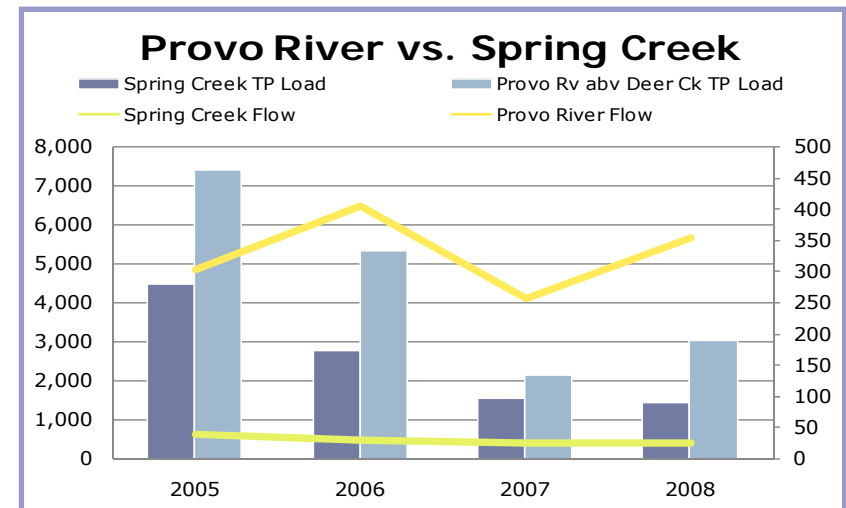
Spring Creek is the major contributor of phosphorus and solids to the Provo River in the Heber Valley. PRWC is conducting additional monitoring to identify the source.

The flood control channel is another major contributor.

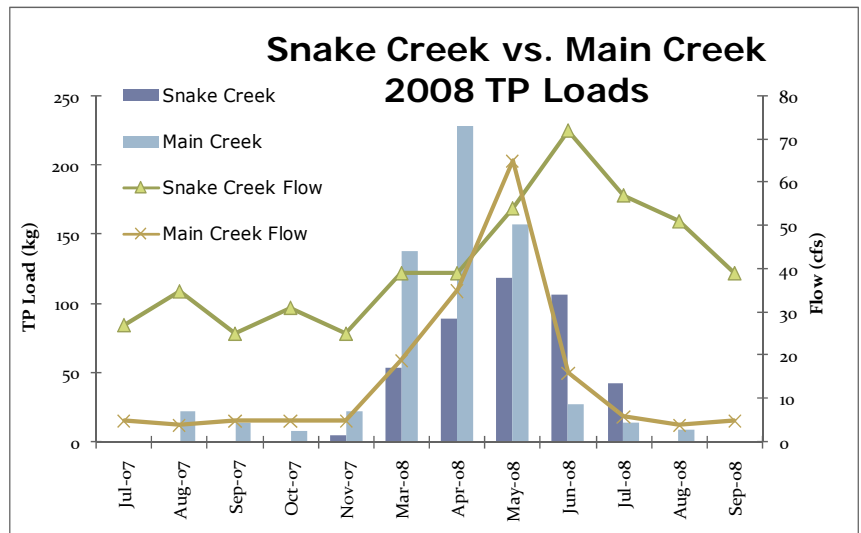
Snake Creek & Main Creek

Main creek continues to exhibit high total phosphorus concentrations. Compared to Snake Creek, which has much higher flows, Main Creek's overall loading is higher. See chart at top. A Watershed Plan is being prepared to identify mitigation measures that may be put into place to control phosphorus coming from Main Creek.

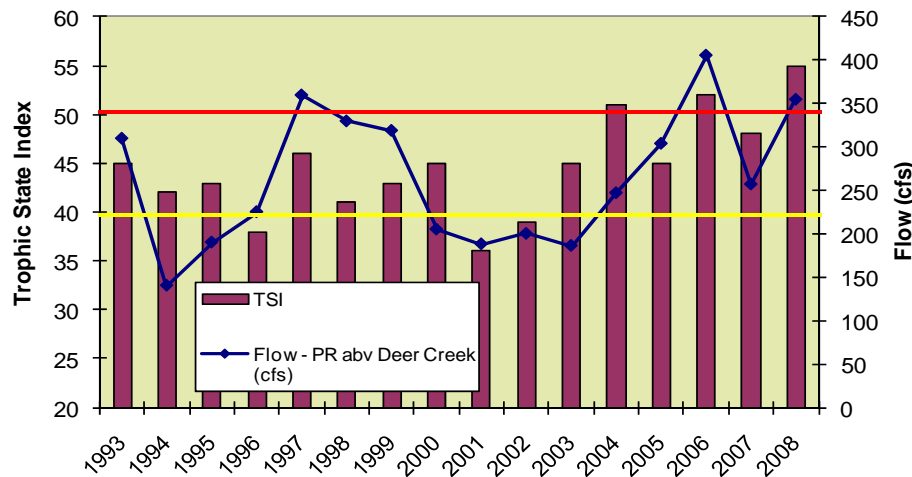
The concept of trophic status is based on the fact that changes in nutrient levels (total phosphorus) causes changes in algal biomass (chlorophyll a) which in turn causes changes in reservoir clarity (Secchi disk transparency). A trophic state index is a convenient way to quantify this relationship.

A lake is usually classified as being in one of three possible classes: oligotrophic (TSI<40), mesotrophic (TSI between 40 & 50) or eutrophic

1. The Trophic State Index, an indicator of biological productivity, in Deer Creek has indicated eutrophic conditions three (3) out of the last five (5) years. This may be a product of the recent draining of Deer Creek for construction. With construction completed operation of the reservoir will return to normal. If there are average weather conditions the reservoir should level out at a mesotrophic state.

2. The trend in TSI over the last 15 years has been increasing. If this trend continues, even once the reservoir is operated under normal conditions, then a mitigation and restoration plan should be considered for the reservoir. Since nutrient loadings to the reservoir have been high during the August to October time frame the mitigation plan should focus on measures that can reduce the late summer and early fall nutrients. The question arises as to whether new suburban development is having a big impact on nutrient loadings.

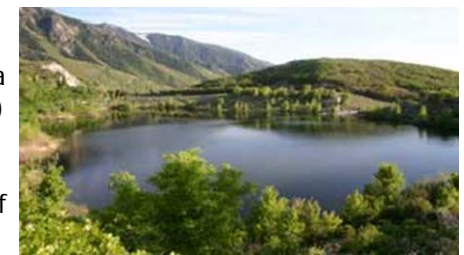
3. High Temperatures (nearly 22 degrees C in summer) in a significant portion of the water column (down to 23-feet) combined with Low Dissolved Oxygen Concentrations have been a consistent reoccurring problem. This situation may lead to fish kills in the future since much of the water column is not favorable fish habitat.

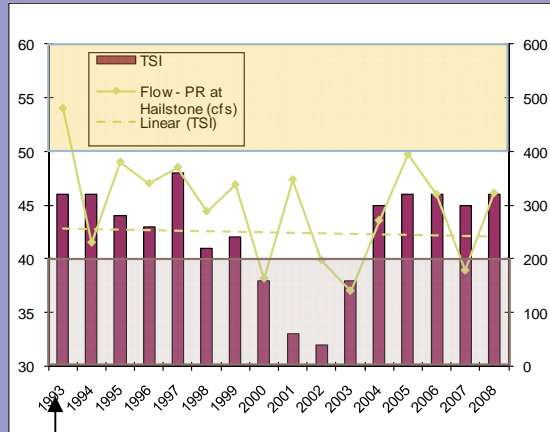
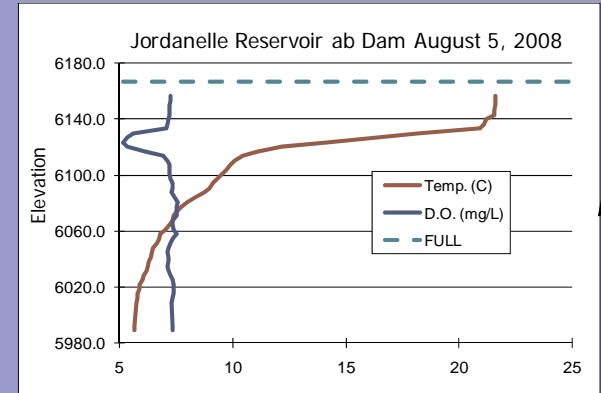
- Jordanelle is a rather healthy lake. Its Trophic State Index has been consistently around 45 (in the middle of the mesotrophic zone) for the past five years. This, even though the flows into the reservoir have been quite different over that five year period. See Figure above.

- The profiles within the reservoir exhibit a strange phenomenon as shown in the figure above. In the area of the thermocline there is also an area where the dissolved oxygen is reduced. However, the D.O. rises in the lower portions of the water column.

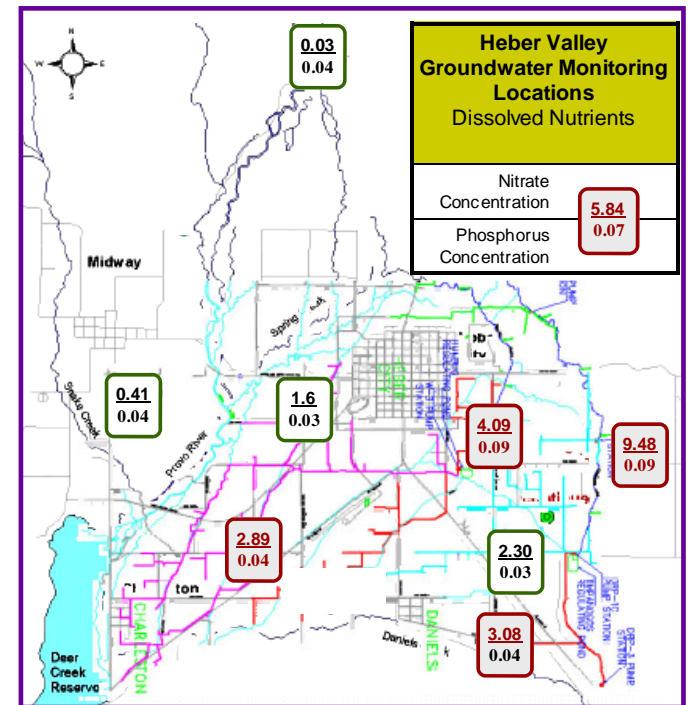
- The map to the right shows the location of the groundwater monitoring wells in the Heber Valley along with the Dissolved Nitrates and Dissolved Total Phosphorus concentrations. Higher concentrations of both nitrates and phosphorus are continuing to increase along the southeastern and south side of the valley. The reasons that these increases are occurring has not been identified. A study of the impacts that localized projects have had on the groundwater quality in the area should be conducted to determine the cause of the increasing concentrations.

The table to the left shows results of groundwater sampling at the locations shown in the map below. There have been increasing levels of dissolved nitrates in four of the wells (highlighted). Also, levels of dissolved phosphorus are high in three of those same wells (highlighted). These wells are concentrated in the south and southeast areas of the Heber Valley.
